ROSEVILLE
REQUEST FOR COUNCIL ACTION

Item Description: **Community Development Department Request to declare the vacant accessory structure located at 2609 Snelling Curve a hazardous building and to order it's repair/removal or razing.**

REPORT ON ROOF AND STRUCTURAL CONDITIONS FOR - 2609 SNELLING CURVE

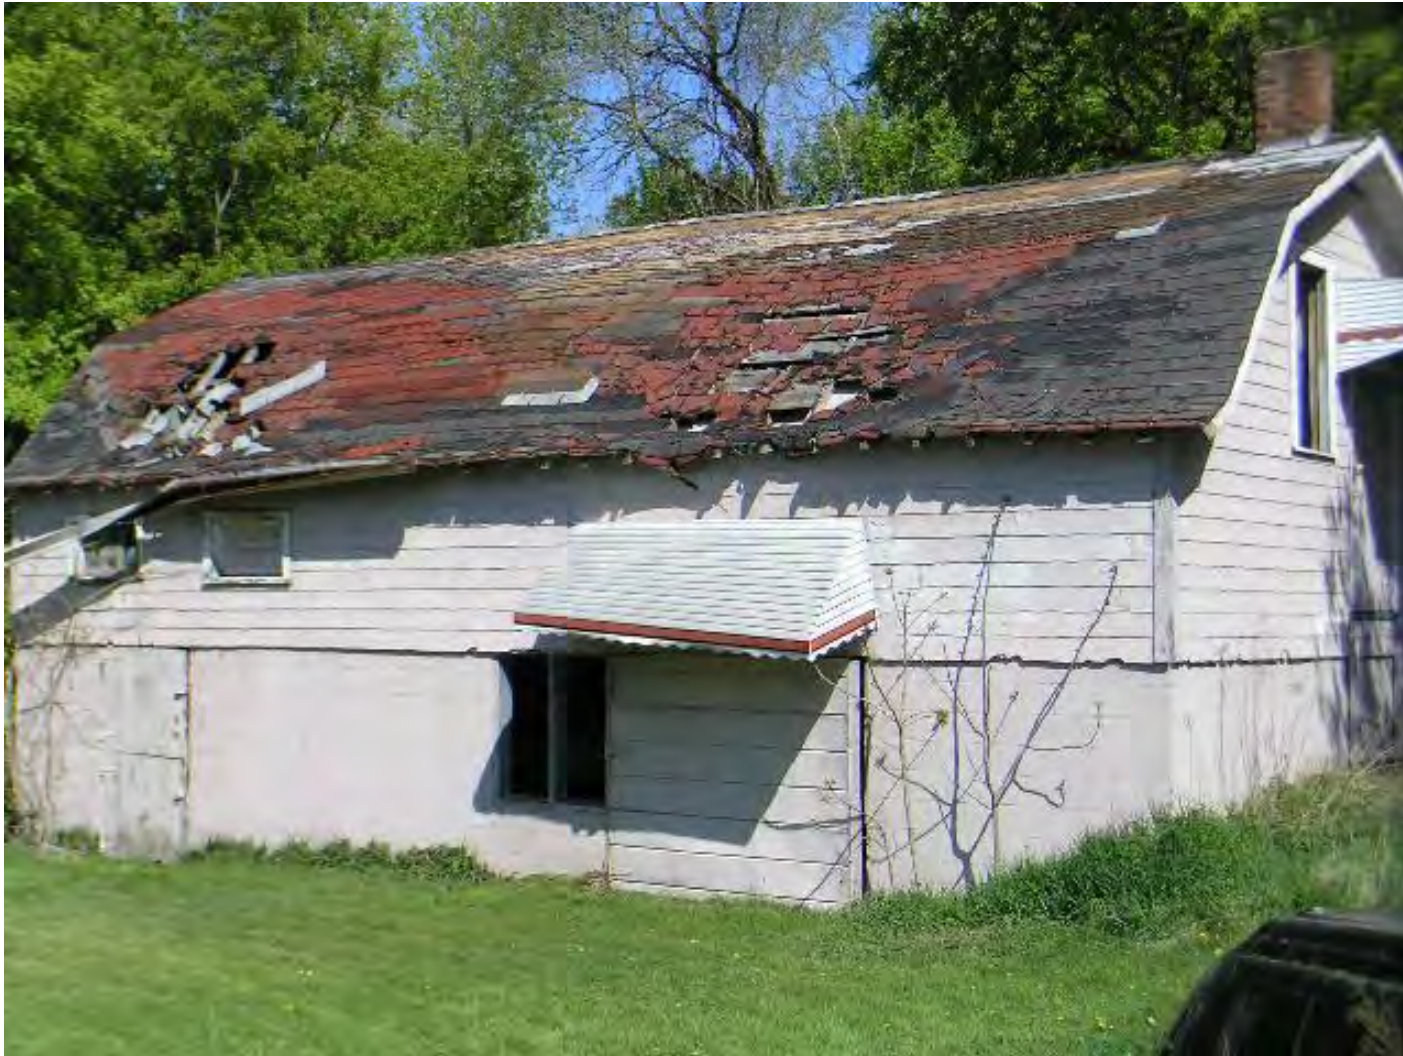
ATTACHMENT B

- The accessory structure located at 2609 Snelling Curve exhibits characteristics constituting a hazardous building due to the following conditions:
 - The roof covering of the building on the south side is significantly deteriorated with two large holes completely through the shingles and the roof boards. See pictures attached.

- The structural elements supporting the roof are deteriorating and the roof is now sagging in these two areas. This indicates that the structural elements are compromised and the roof could collapse, most likely under the weight of a winter snow load. See inspection report attached.

An observation from the exterior of the structure shows that the south facing side of the roof has deteriorated to a much greater extent than the north side. Several layers of shingles have been deteriorating over the years and have now exposed the wood framing of the compound rafters. This direct exposure to the weather and the preceding years of saturation from failing shingles has compromised the structure through rot of the rafters themselves and additionally their connections to the wall and floor system that ties the building together. Two large openings in the roof are present and have exposed the interior directly to the sky with no resistance to the elements. Presently I would estimate that the south facing half of the roof has approximately 25% of its rafters visibly exposed and completely severed somewhere along their length through the action of decay. Additionally the visible deflection in 25% to 30% of the rafters adjacent to the openings also appear to indicate that they are severed as well. These rafters also are not performing their intended purpose and are most likely not benefitting the roof for support in any fashion.

- Repair/replace all compromised structural elements in the accessory structure supporting the roof.
- Repair/replace all compromised roof sheathing in the accessory structure.

- Replace all deteriorated roofing on the accessory structure.
- Repair and re-secure all exterior doors, windows and entrances to the building and remove all plywood boarding;
